## Section 19 Flood Investigation Report

Section 19 Flood Investigation Report: Begbroke  
Date of Flood Incident: 23rd and 24<sup>th</sup> September 2024

This Section 19 (S19) Flood Investigation Report has been issued by Oxfordshire County Council (OCC) in its capacity as Lead Local Flood Authority (LLFA). It is based upon an investigation by OCC and Cherwell District Council (CDC) into the Begbroke September 2024 floods.

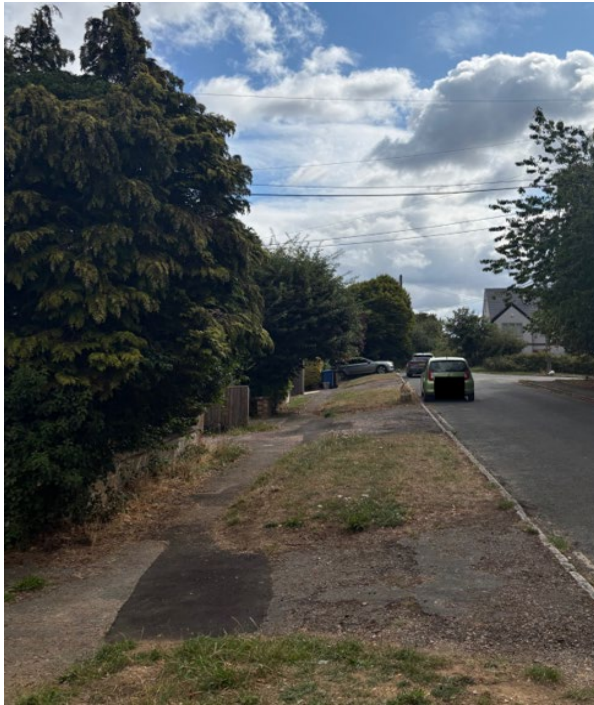
Along Begbroke Lane, the team observed a steep gradient sloping towards the properties on the northern side, which may contribute to surface water runoff being directed toward these homes (Figure 11). Although the Highways drainage infrastructure appeared to be clear at the time of the visit, it is important to note that post-event reports indicate that both OCC Highways and residents undertook clearance efforts following the September 2024 flood. As such, the observed condition of the drainage system may not accurately reflect its state during the flood event (Figure 12).

The combination of this flow path, the steep road gradient, and reports of silted drainage infrastructure suggests that surface water reaching the front of the properties may have been unable to drain effectively, resulting in pooling within the Begbroke Lane area.

*Figure 11 – Slope on north of Begbroke Lane (Site Visit: 2025)*

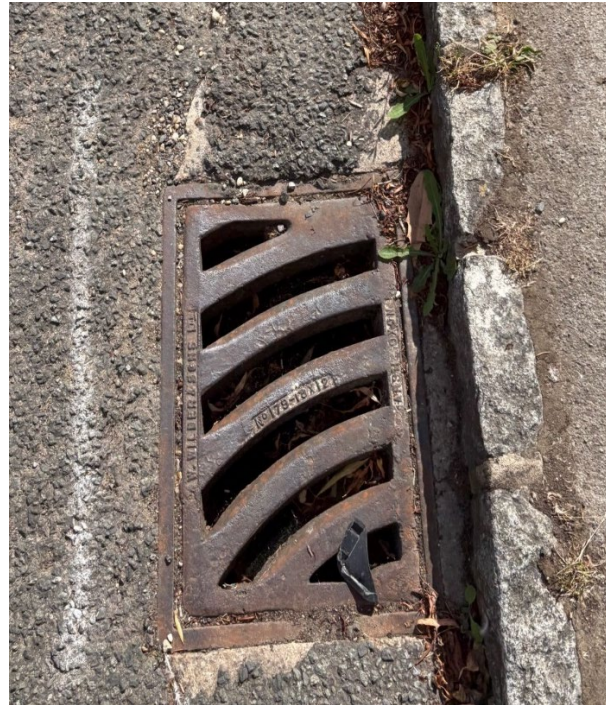
*Figure 12 – Drainage infrastructure on Begbroke Lane during site visit (Site Visit: 2025)*

| Recommendation | Lead Stakeholders | Consulting stakeholders | Time Frame (from publication)<br><br>Short term – delivered within 6 months<br><br>Medium term – 1 - 2 years<br><br>Long term - 2 years +<br><br>On-going - Continuous activities |
|---|---|---|---|
| Review the current maintenance for highways drainage assets on Begbroke Lane, and look to increase the frequency of cleaning, in line with current Highway Maintenance Programme and funding availability. | OCC Highways | | Medium term |

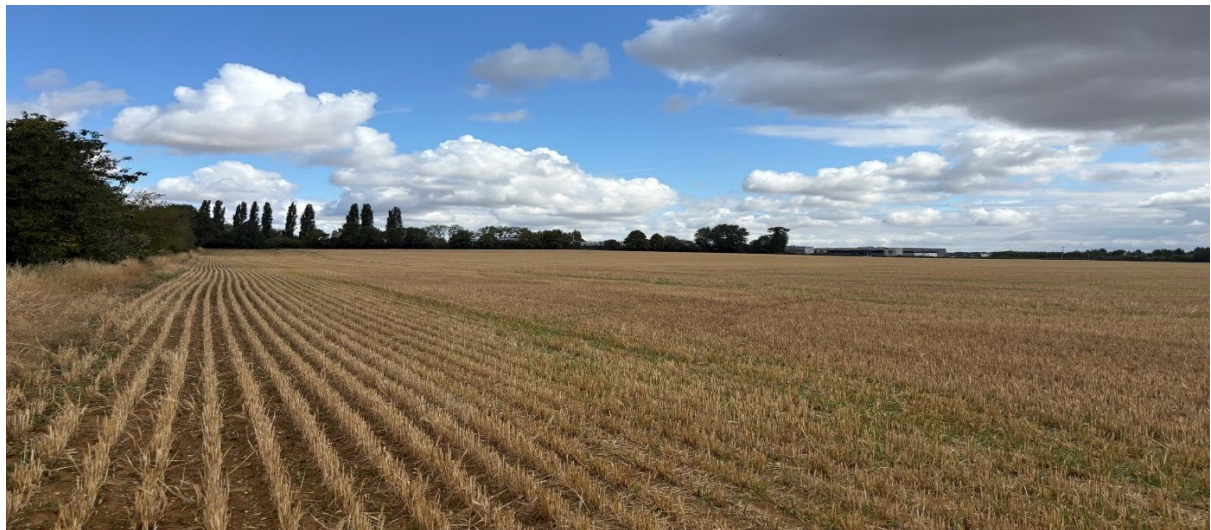
Discussions with residents and observations in the field to the northeast of Begbroke Lane revealed that surface water tends to originate from the northern boundary of the field and flows southward, guided by the natural topography and potentially influenced by agricultural practices (Figure 13). These factors appear to channel water toward the rear and front gardens of properties along Begbroke Lane. This inferred flow path is supported by the RoFSW data and drainage mapping presented in Section 1.2.

*Figure 13 - Fields north east of Begbroke Lane taken from the south western point of the field (Site Visit: 2025)*

| Blenheim estates, CDC and OCC to assess the feasibility of implementing drainage ditches along the edge of the Blenheim Estate owned field to direct water flow south-eastward, with the aim of discharging into the Rowel Brook at a point downstream of the village. | Blenheim Estates, OCC LLFA, CDC | | Medium term |

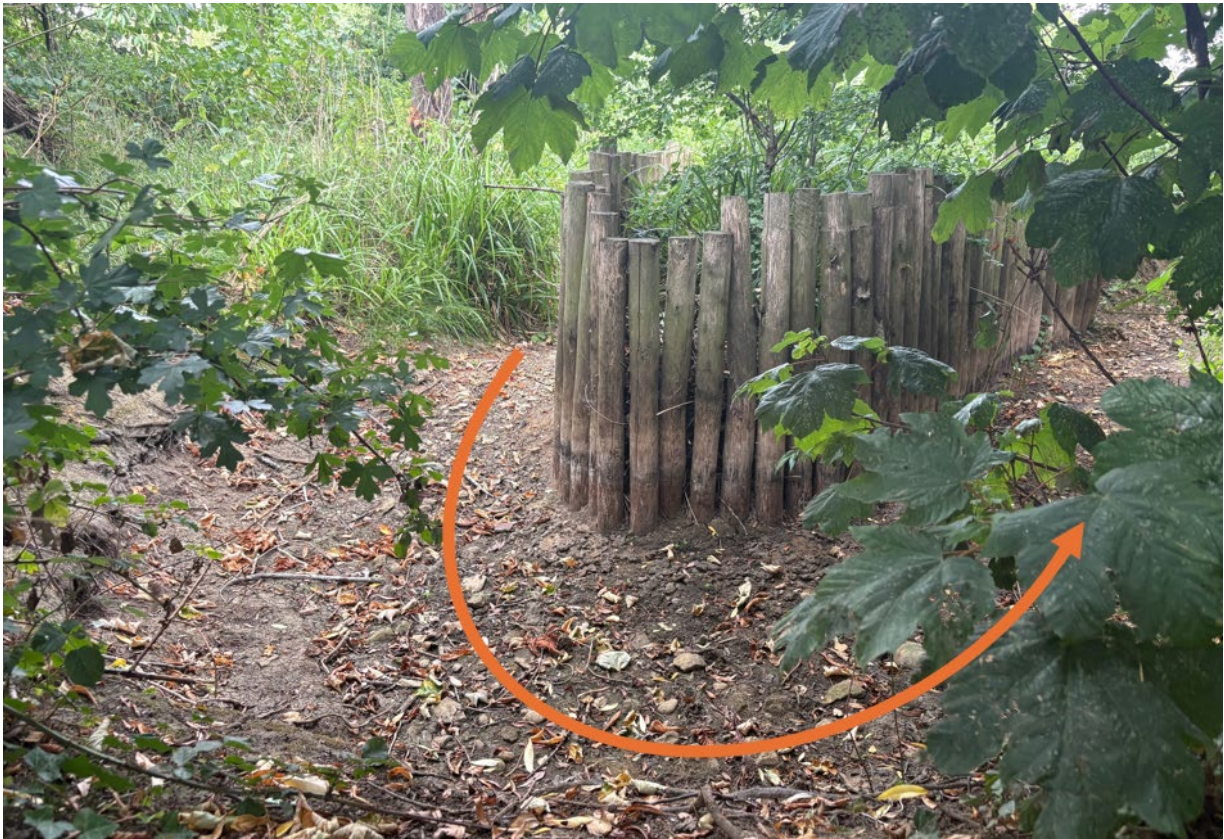
During the walk along Rowell Brook, the team observed that the watercourse upstream of the affected properties was heavily vegetated. The build-up of material along the banks may pose a risk of being mobilised during future flood events, potentially exacerbating downstream impacts. Whilst the watercourse was dry at the time due to antecedent conditions, several meanders were also noted, which are likely to contribute to slower conveyance through this reach (Figure 14).

*Figure 14 - An example of a sharp meander on the Rowell Brook with flow direction arrow (Site Visit: 2025)*

| Environment Agency to remind landowners of their legal obligations to carry out watercourse maintenance in accordance with their riparian owners' responsibilities. This is particularly relevant for the stretch of the Rowell Brook at the southern limit of the village. | Landowners | Environment Agency | Medium term |

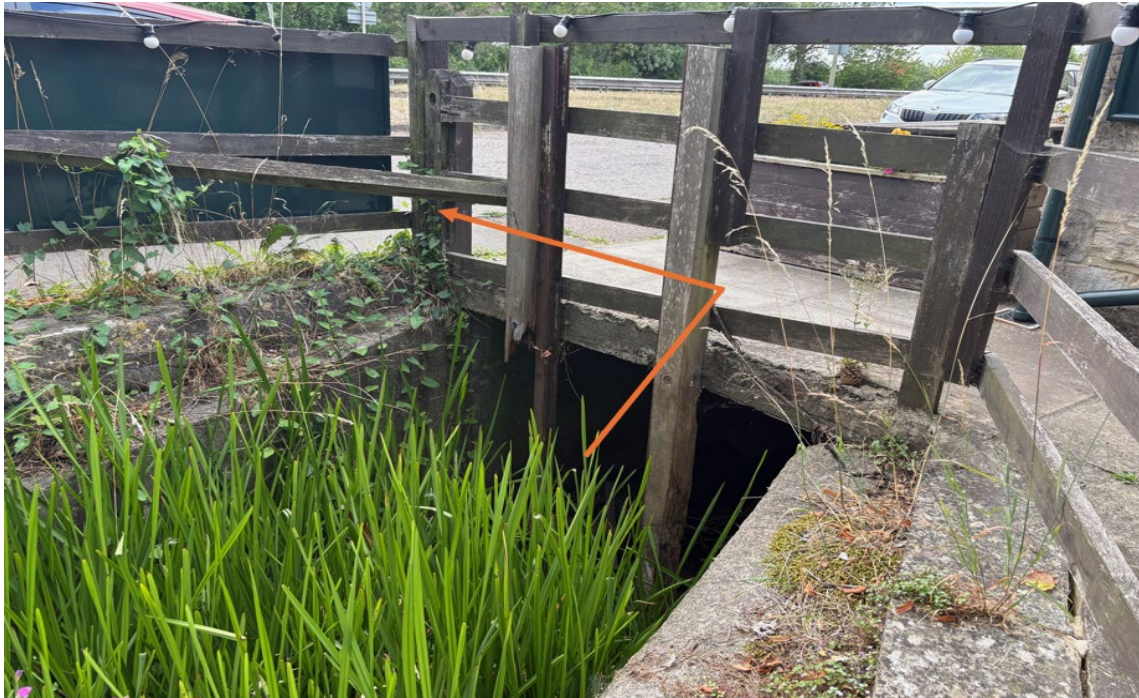
The walkover survey of the area surrounding the A44 roundabout provided further evidence that the culverted section of Rowell Brook beneath the A44 is likely a key contributor to the flood event. Both the culvert inlet (Figure 15) and outlet (Figure 16) feature sharp 90-degree bends, which are likely to restrict flow efficiency and increase the risk of out of bank flooding at the inlet during high-flow conditions. The presence of sandbags, which were observed near adjacent commercial properties to the Rowell Brook in this location, further support assessment. Their presence provides an indication of previous flood mitigation efforts in response to flood risk at this location.

*Figure 15 – Rowell Brook A44 culvert inlet with orange flow direction arrow (Site Visit: 2025)*

| OCC Structures to conduct investigation into the current capacity, operation and efficiency of the A44 culvert with the aim of identifying issues and potential solutions to improve conveyance without increasing downstream flood risk. The OCC Structures Team confirmed that if there were any major obstructions in the future, clearing of any debris upstream and downstream would need to be undertaken before any jetting / clearing of the culvert would be completed. | OCC Structures | EA, OCC LLFA, CDC, OCC Highways | Medium term |

OCC Structures Team inspected the culvert on 05/03/2025 and removed a few minor obstructions. They did note that if there were any major obstructions in the future, clearing of any debris upstream and downstream would need to be undertaken before any jetting / clearing of the culvert would be completed.

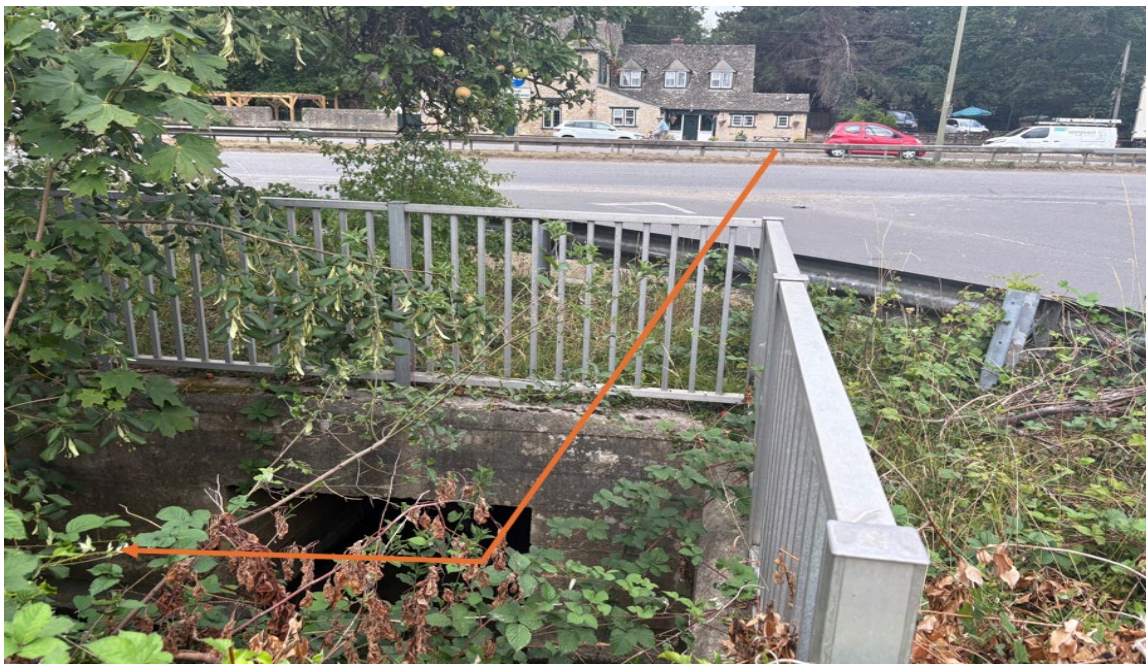
*Figure 16 - Rowell Brook A44 culvert outlet with orange flow direction arrow (Site Visit: 2025)*
